CRANBROOK REGION

PHOENIX

Property name: PHOENIX
Map number (see Appendix C): 20
Mine drainage sample numbers: LB00-1801 to 1803
MINFILE number: 082ESE020

Date: September 11, 2000
Persons present: Steve Wuschke (Mining Division, Cranbrook) and L. Barazzuol (Mining Division, Victoria).
Weather: sunny and warm, late afternoon

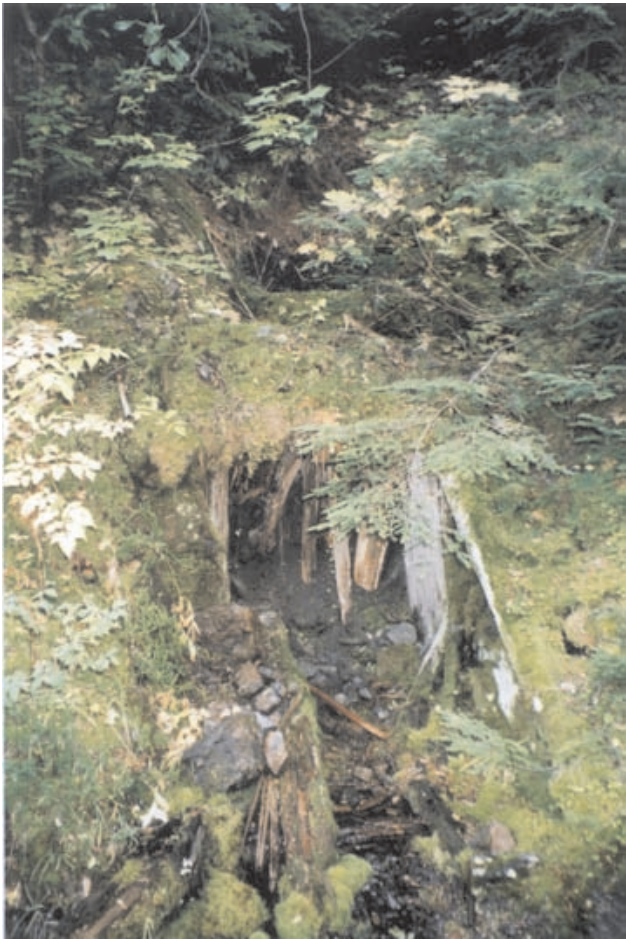
An unknown adit was located on the Idaho Peak lookout road, including a partially collapsed mill. S. Wuschke noted that the tailings had previously been sampled. UTM coordinates: 480898, 5537557, elevation 1419 m. These workings could be part of the Queen Bess property (082FNW010).

Photo 54. Unknown adit on Idaho Peak, elevation 1419 m.
